## Exhibit 26

Subject: Hot Shot Sighting

## Sharing – Rockefeller Concourse

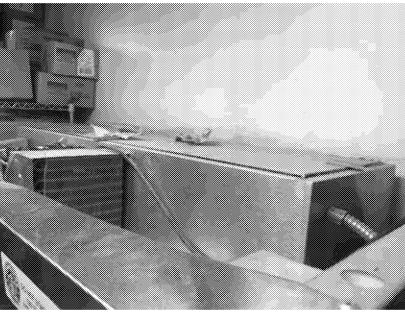
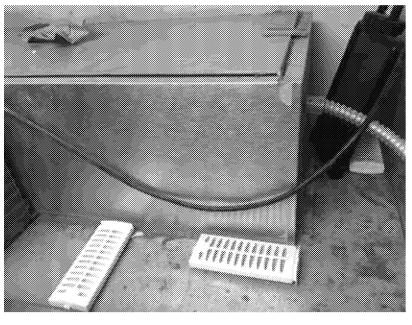
In addition to the 3-DR reach-in fridge missing its top cover, having excessive build-up and debris - 5 hot shots found. Also found another 2 in the base of their hot water heater (Jasmine- similar to 7465, 59<sup>th</sup> & Columbus with Carrie).

I will be seeing the DM later and coaching the new SM that transferred-in this week.
